Report Number	XNLR-4597-8496-4419
Report Template	OVIQ2 (7105)
Vessel Name	SMS Valiant
IMO Number	9581394
Date of Inspection	16 Sep 2015
Port of Inspection	Kali Baru Jetty Marunda, Jakarta
Inspecting Company	Chevron Shipping Co. LLC

## IMCA Safety Flash 13/15

September 2015

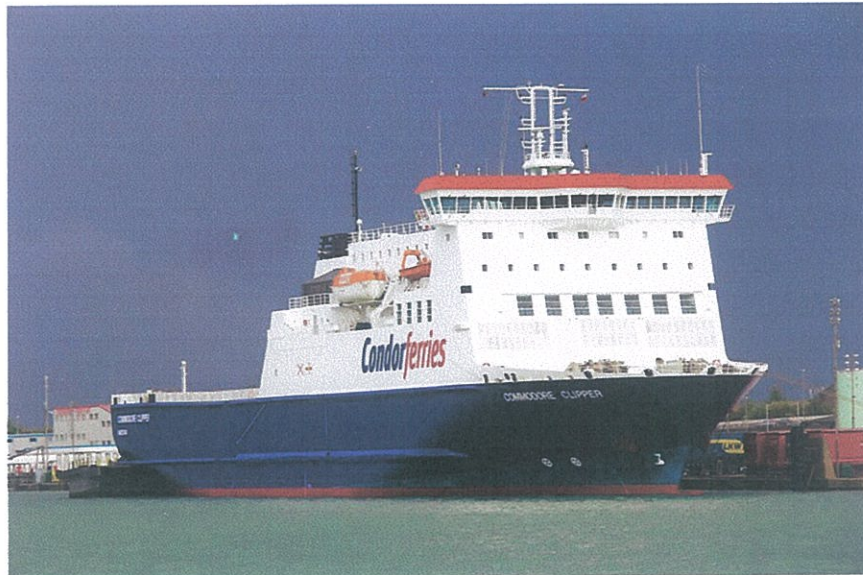
The UK Marine Accident Investigation Branch (MAIB) has published a report into the grounding and flooding of the ro-ro (“roll on roll off”) ferry *Commodore Clipper* in the Channel Islands in July 2014. The vessel raked over two granite pinnacles at full sea speed of about 18 knots; its hull was breached and seawater flooded into double-bottom void spaces. The grounding caused a noisy and shuddering vibration, but the crew did not immediately check for damage.

- ◆ Insufficient passage planning meant that the bridge team were unaware of the limits of safe water where the vessel was heading, and so headed into danger without appreciation of the navigational risk. A number of issues were not properly considered:

- The very low tide;
  - The effect of vessel ‘squat’ in shallow water at high speed;
  - The accuracy of the chart data.
- ◆ The possibility that the vessel had grounded was denied. In the circumstances of a shuddering vibration, it is important that the crew establish the state of their vessel by searching for damage;

- ◆ The repetitive nature of ferry operations can induce a degree of complacency when planning;
- ◆ The electronic navigation system was not being utilised effectively because safety settings were not appropriate to the local conditions, warnings were ignored and the audible alarm was disabled;

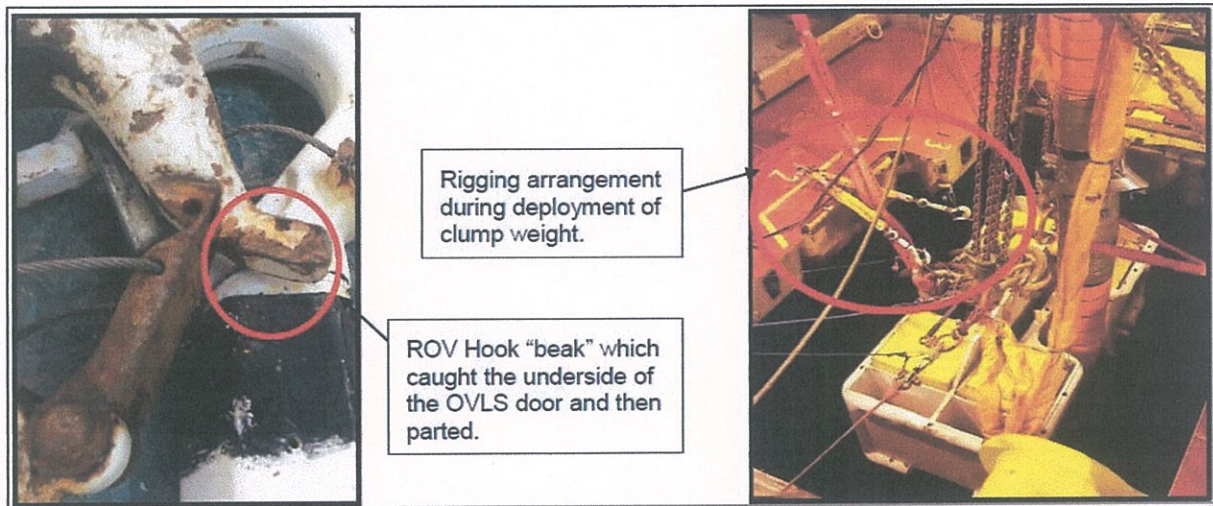
Once deployment of the clump weight had come to a stop, tension was released from the hold-back winch, and a rigger was instructed to enter the work area and disconnect the two slack ROV hooks by pulling on release ropes. The deck supervisor then signalled for the winch operator to commence hoisting up on the winch. It was during the winch hoisting movement that the “extension beak” on one of the ROV hooks got snagged. The beak parted which resulted in the two part bridle complete with ROV hooks and winch wire flying up and striking the rigger knocking him off his feet to deck.

- ◆ Lack of hazard awareness and consequence for a routine task;
- ◆ Low risk perception to the task because of other associated higher risk tasks in the same area;
- ◆ The need to identify and mitigate all risks associated with a Management of Change (MoC) process;
- ◆ The Management of Change process should recognise where appropriate the introduction of required additional personnel into the task.

Showing ROV hook beak (left) and rigging arrangement (right)

- ◆ Deck review to identify potential snap back zones and all lines of fire zones for all winch operations;
- ◆ Review of where crew are standing whilst doing this particular job;

- ◆ Further crew briefings covering:
  - Toolbox talk training and workshops
  - Line of fire awareness briefing (IMCA);
- ◆ A review of the Management of Change process and Job Risk Analysis for this operation;
- ◆ Assessment of suitability of ROV hooks for deck rigging activities;
- ◆ Assessment of task procedures and risk assessments – are they available, understood and do they reflect the way the job is actually being carried out;
- ◆ Consideration of possible negative or unforeseen effects of changes made to improve how a task is done;
- ◆ Consideration of the required sequence of activities (e.g. who, what, when?) and agreement and confirmation of readiness before starting work;
- ◆ Identification of any operations/tasks which could expose personnel to a “line of fire” risk.

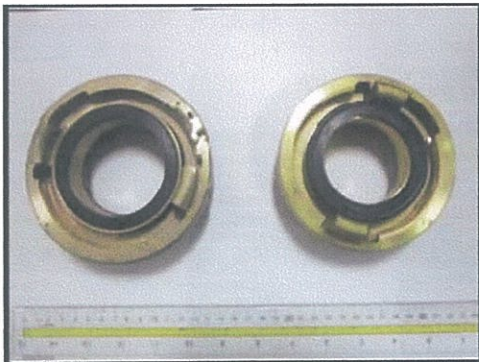
A member has reported an incident in which replacement fire hydrants were found to be fitted with incorrect coupling sizes, leading to them being incompatible with fire hose couplings. This would have severely impacted the firefighting capabilities of the vessel. The incident occurred following a number of earlier occasions in the previous five years in which fire hydrant valves in the accommodation had been found leaking. Replacement hydrants were ordered and fitted, but the couplings were found to be incompatible. It was found that the coupling on the hydrant valve in the port side forward thruster room did not fit the adjacent fire hose coupling. The hose coupling measured 65mm and the hydrant coupling measured 80mm.

65mm hose coupling on right and 80mm hydrant coupling on left

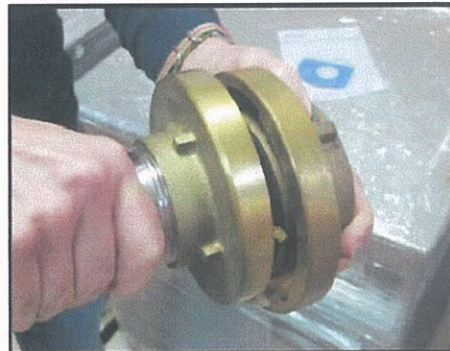
80mm hydrant coupling not compatible with 65mm hose coupling

- ◆ The hydrant/hose coupling incompatibility was not followed up in a timely manner. Six days elapsed between the discovery of the incompatibility and a Hazard Observation being made;
- ◆ A total of thirty hydrant couplings were found with 80mm couplings fitted instead of 65mm couplings. Had there been a fire these thirty couplings (incompatible) on the fire hydrants would not have been serviceable;
- ◆ Firefighting capabilities were not entirely restricted as the outside accommodation fire hydrants on each deck were still pressurised and compatible with the fire hoses onboard and the shipboard accommodation sprinkler fire suppression system was available.

- ◆ The need for vigilance and the importance of thorough inspections and correctly completing all checklists, including examination for missing or improperly installed components:
  - Lack of attention/due care/poor work practice
  - Failure to identify incorrect fire hydrant valve couplings during installation of valves
  - The thirty incompatible fire hydrant valve couplings were fitted in May 2014 and this had not been spotted for many months, despite maintenance, safety inspections and drills;
- ◆ When incidents, near misses, issues or concerns are reported, they should be followed up in a timely manner.

Members may wish to check their own fire-fighting equipment, to carefully and thoroughly inspect all equipment when first received, and to ensure that during fire drills, hoses are properly run and connected to hydrants, including in the accommodation areas.

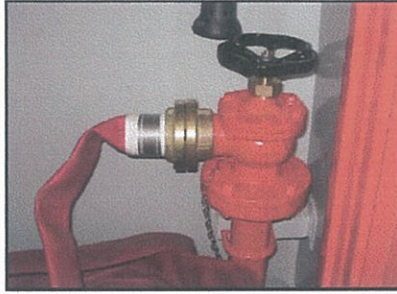
Fire hydrant with correct 65mm coupling  
(compatible with 65mm hose coupling)
